# ARCHAEOLOGICAL MONITORING REPORT

## **‘Goldings’, 67 High Street, Newmarket NKT 076**

A REPORT ON THE ARCHAEOLOGICAL MONITORING, 2004  
(Planning app. no. F/2003/0899/FUL)

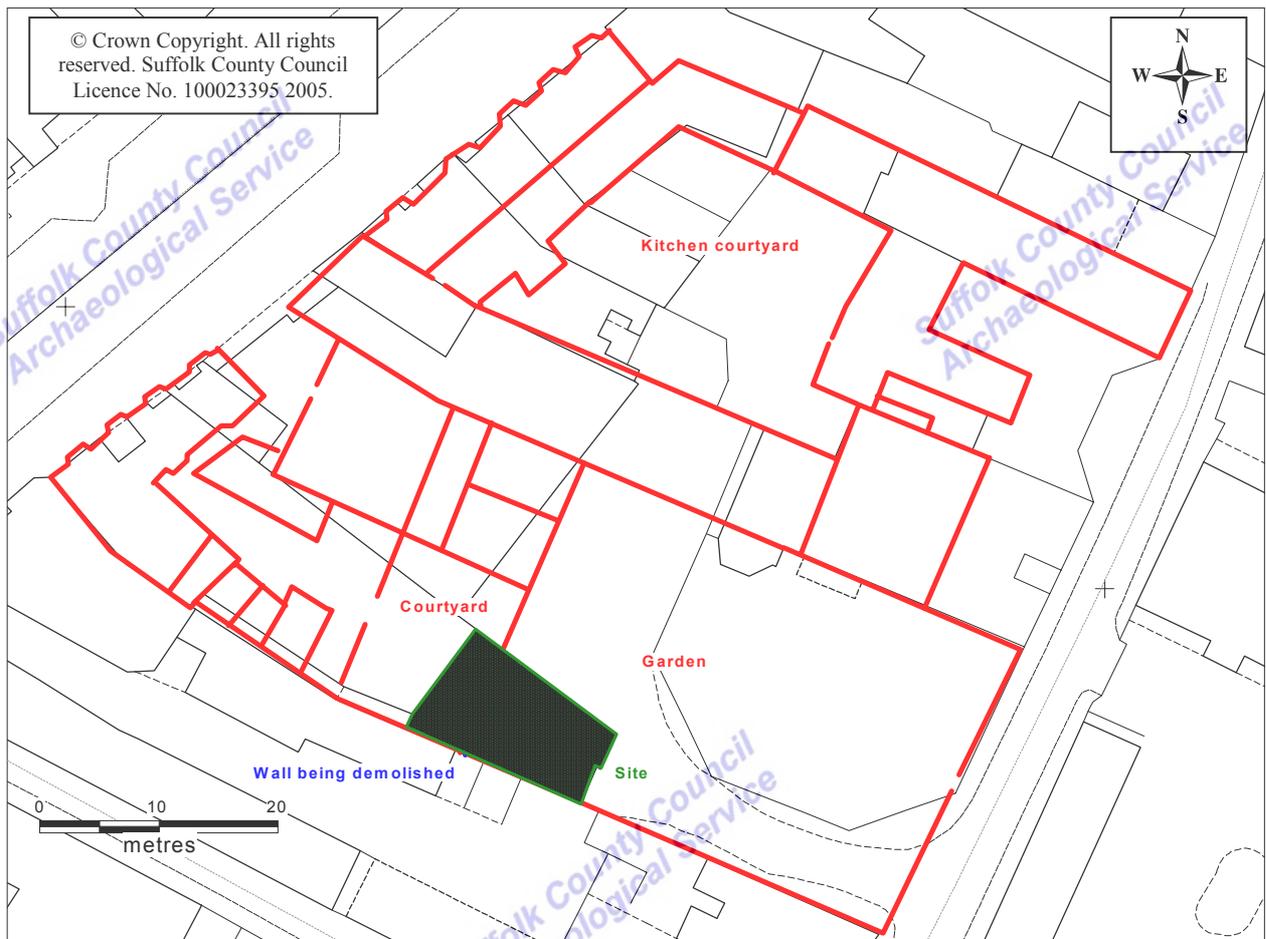
Figure 2. Site in relation to plan of the palace c.1719-1745

The layout of the palace in the 18<sup>th</sup> century has, in many places, been incorporated into and survives as, the modern layout of buildings and boundaries. This can be seen by superimposing a first floor plan, c.1719-1745 (Sommers 2001), onto the current OS (Fig. 2). The development involved the demolition of walls forming part of the garages, one of which appeared to closely relate to a wall shown on the 18<sup>th</sup> century plan as separating the palace garden from an internal courtyard near the south edge of the palace. A gate or archway passed through this wall between garden and courtyard, within the area of the site.

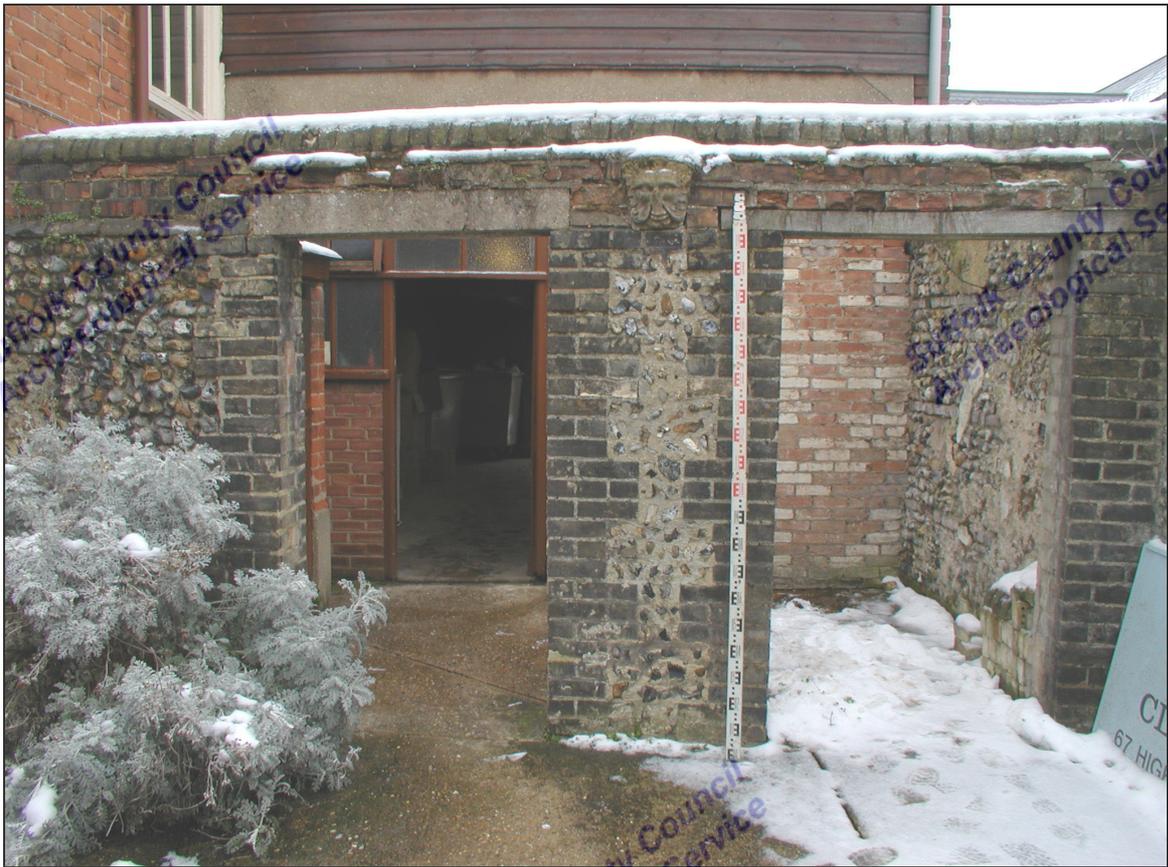
Figure 3. Western face of wall.

The survey of the wall being demolished showed it to be of a 19<sup>th</sup> century date with two doorways through it. It was constructed of closely spaced flints, bonded with lime mortar, with 19<sup>th</sup> century bricks forming quoins. These bricks were 'whites' and measured 8¾" by 2" by 4". The top of the wall, above the two doorways consisted of three courses of red brick

Of particular interest, set into these upper three courses in the middle of the wall, was a reused block of carved, coarse limestone (Figs. 3 and 4). This wedge shaped block measured 0.27m in height and at the top it was 0.26m wide, with a slight concave edge. The sides tapered towards the base which was 0.18m wide. This shape suggests that it was originally part of an archway, possibly the central keystone.

The survey of the standing wall that was facing demolition showed it that it was relatively modern, probably of 19<sup>th</sup> century construction, and clearly not a part of the 17<sup>th</sup>-18<sup>th</sup> century palace. However the wall did reuse some older material in its construction, and in the case of the ‘Green Man’ carving this appears to have been deliberately positioned high up in the centre of the wall.

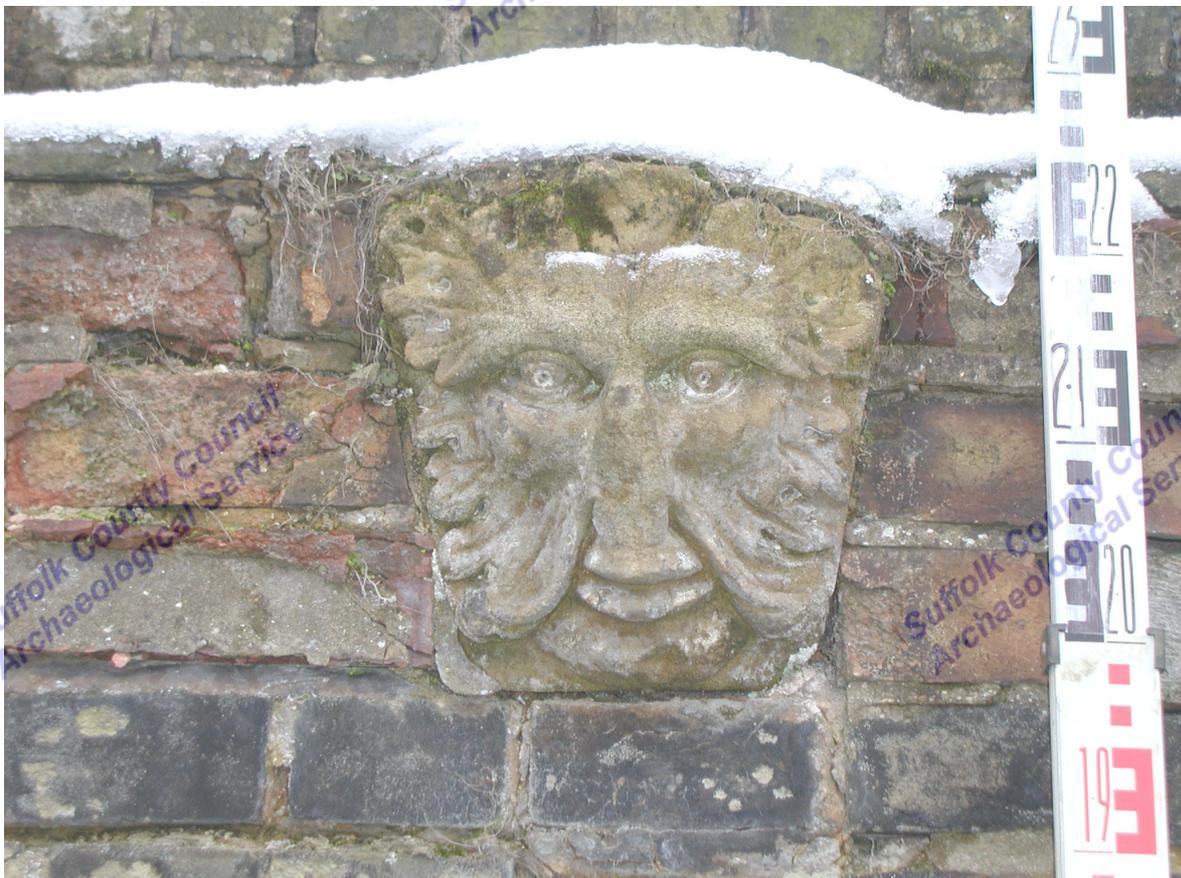
Figure 4. The 'Green Man'

The carving depicted a 'Green Man', a common motif seen in varying styles and periods across Western Europe. This example showed a male face with thick hair or vegetation down the sides and over the cheeks, with a bare chin. The carving was in a good condition, with the exception of the nose, which had been broken off, and the detail was fairly clear showing limited weathering.

The carving itself is in good condition suggesting a post-medieval date as opposed to an earlier, medieval one. This would suggest that it is probably contemporary with the palace and is likely to be from a structure within it. As the modern wall was in close proximity to the location of the wall and gateway that divided the palace courtyard and garden it is possible that its construction involved the demolition of the earlier structure. The ‘Green Man’ therefore could be the keystone of an arch over that gateway within the palace wall, which was rescued and deliberately placed back near to its original position in the 19<sup>th</sup> century wall.

Finally, in view of the possible original location of the 'Green Man' and its survival in the modern wall, it was informally suggested that it could be reincorporated into the new development.

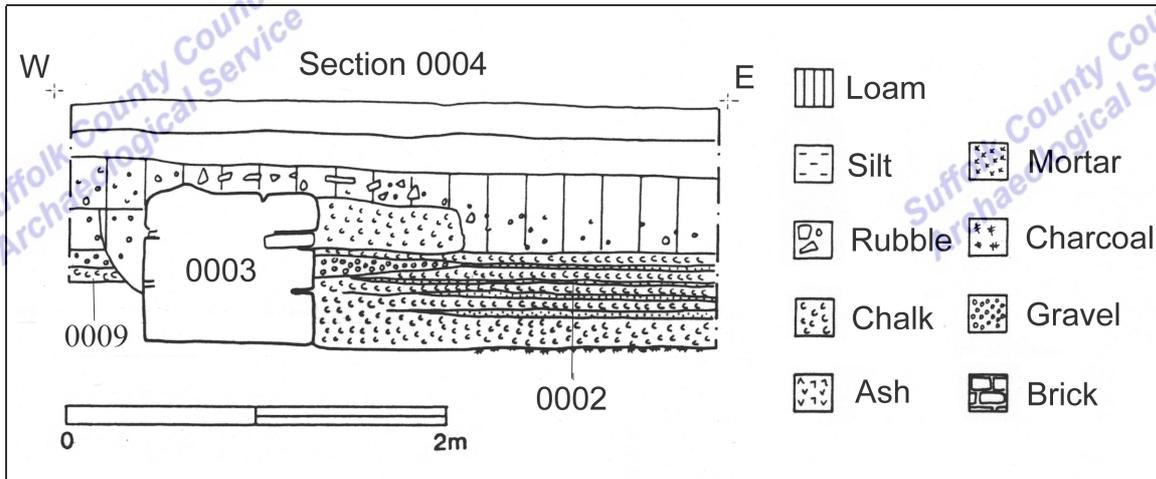
Figure 6. Section 0004

0003 was the foundations and base of a wall, built from chalk blocks, handmade red bricks of 17<sup>th</sup> century date measuring 2½” wide, and occasional pieces of re-used, dressed limestone. It was seen at several points in the trenches, aligned north - south, and measuring 0.8-0.9m in width and approximately 0.8m in height. The uppermost course generally laid directly beneath modern deposits while the base appeared to be resting upon the natural subsoils.

In section 0004 (Fig. 6) it was clearly associated with the chalk surfaces 0002 which butted against its eastern face. On the western side it appeared to have a construction trench which cut through the 0009 surface. To the south it could be seen in section 0005 (Fig. 7), again with surfaces formed by lenses of chalk, 0010, on either side

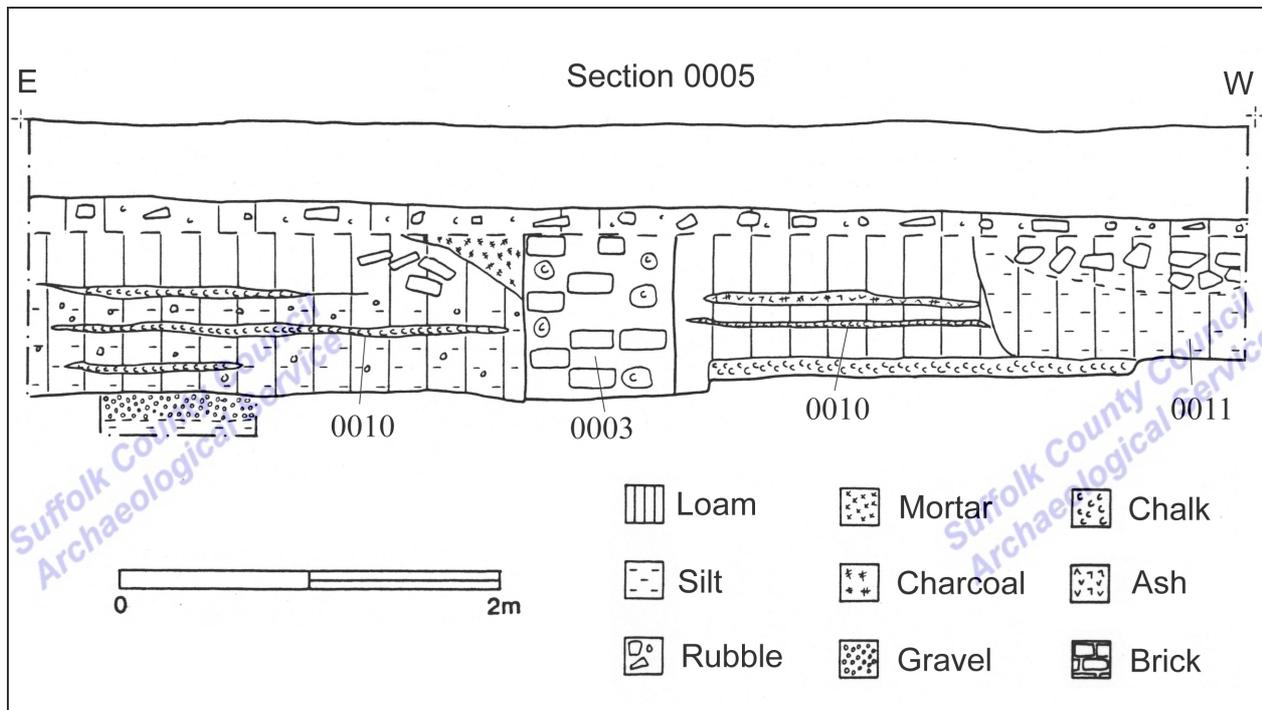
Figure 7. Section 0005

0011 appeared to be a large pit, cutting through the chalk lenses 0010 in section 0005. It was filled with a homogenous grey/brown silt loam mixed with building rubble.

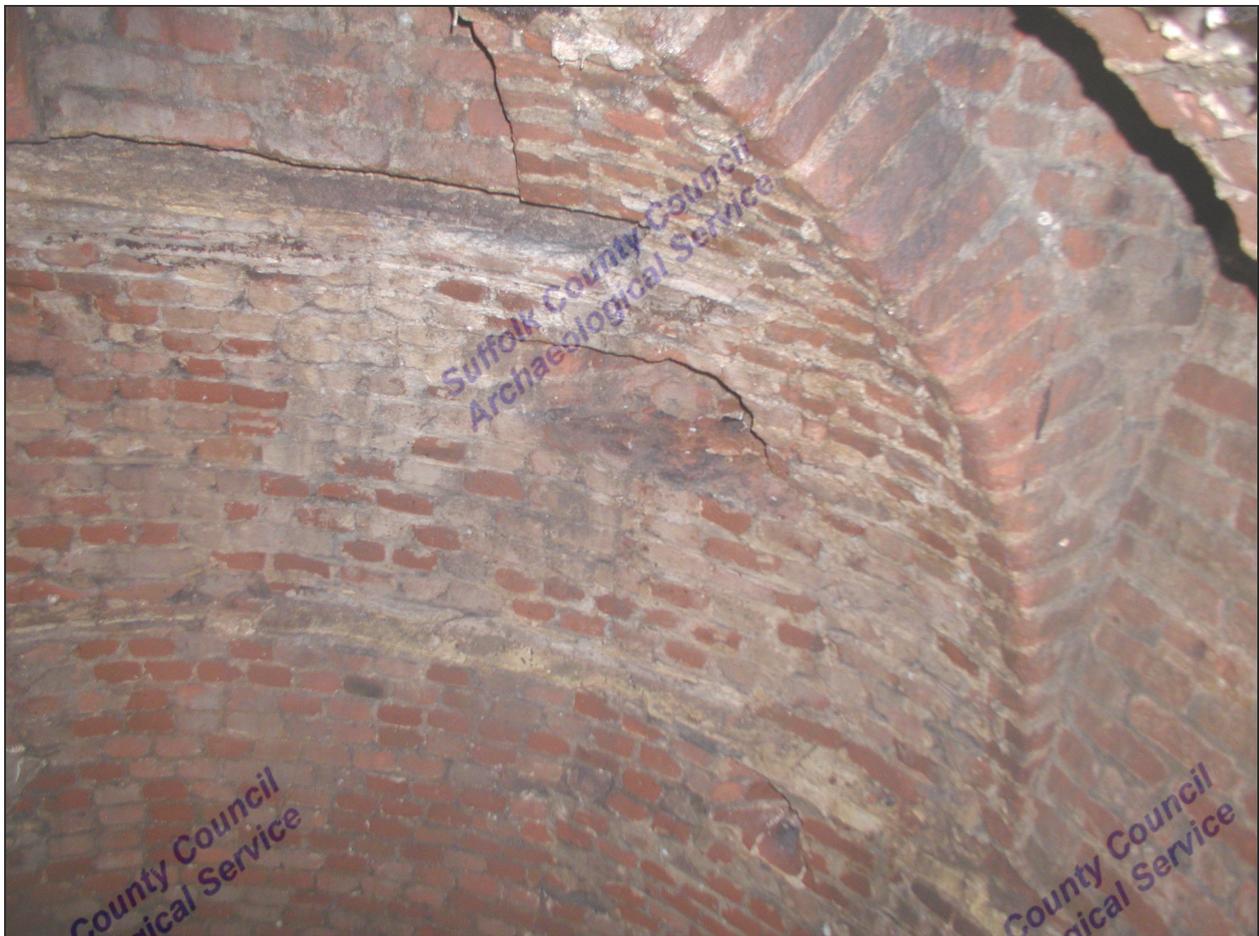
Figure 8. Interior of 0008 icehouse

0008 was a substantial, brick lined, circular shaft, estimated to be 4.3m in diameter which cut through the chalk surface 0002. Constructed of red brick of 17<sup>th</sup>-18<sup>th</sup> century date the shaft walls were 0.5m thick, leaving a central shaft 3.3m in diameter. The top of the feature, from the outside was unclear but appeared to be domed and survived in full, beneath 0.4m of modern deposits. During excavation of the trenches a hole was knocked through this dome allowing a very limited observation of the interior (Fig. 8). This showed it to be 10.7m deep, with approximately 8m of standing water. The interior of the dome was ribbed vaulted with brick groins. Further later brickwork appeared to be infilling original openings through the dome.

0008 in fact appears to be the palace ice-house, as opposed to a well, situated within a corner of the palace garden. Its size and structure is more appropriate to this function and is similar to other known examples. For instance a contemporary 'snow-well', built in 1666-1667 in St James's Palace, London, for the Duke of York, measured 3m wide and 8m deep (Beamon and Roaf 1990).

For health and safety reasons the top of the ice-house, both interior and exterior, could not be properly recorded but at least two original openings within the dome structure were visible. The dome would have sat above ground level and these openings must have allowed access to the interior. These openings were later blocked with brickwork, presumably when the ice-house fell out of use, and certainly by the time the existing 19<sup>th</sup> century wall was constructed above it. A 19<sup>th</sup> century date for the closing of this ice-house corresponds with the probable demolition of 0003 and the known changes in use and structure of the palace.

Only a few ice-houses, probably less than a hundred, were built during the late 17<sup>th</sup> century and it is not known if any of those built for Charles II survive. Following monitoring work a larger hole was knocked through the dome so that the interior could be infilled with gravel prior to development. This means that the bulk of the structure is now preserved intact below the modern development and is probably one of the earliest known surviving examples in Britain.

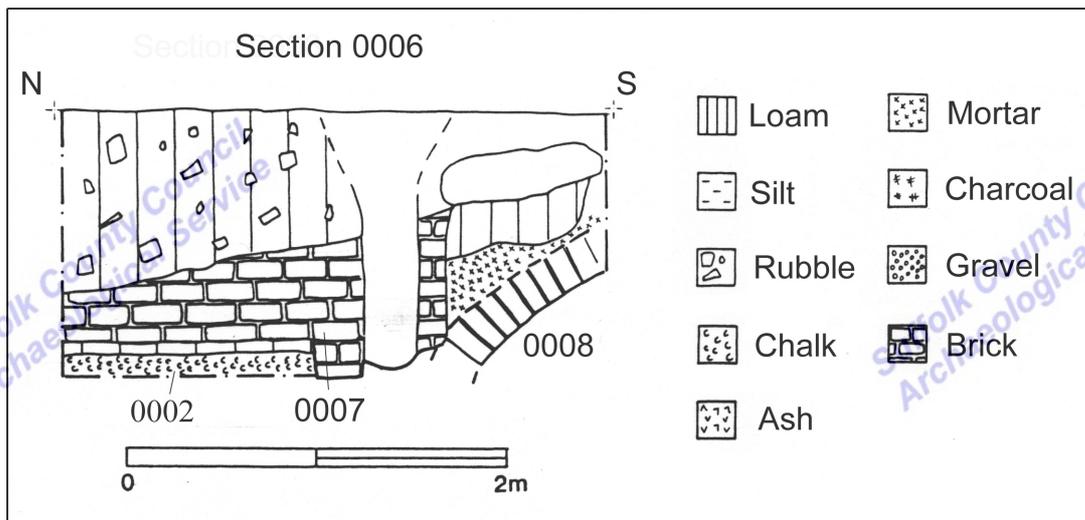
Figure 9. Section 0006

0007 was a length of red brick wall, aligned north-south, of which the western face was seen in section 0006 (Fig. 9). Approximately seven courses of brickwork survived, forming a total height of 0.7-8m. The uppermost course lay beneath 0.7m of rubble and modern deposits while the base appeared to be resting upon or cutting into the chalk surface 0002.

To the north this wall left the trench and its extent was unclear, to the south it was considerably disturbed although it appeared to butt against the brick lined well 0008.

The wall 0007 is of unclear size and function but may be contemporary and related to structures around the top of the ice-house.
